JCAT Mission (U)

Executive Summary (U)

CH-47D EXTORTION17

PROBABLE OG-7

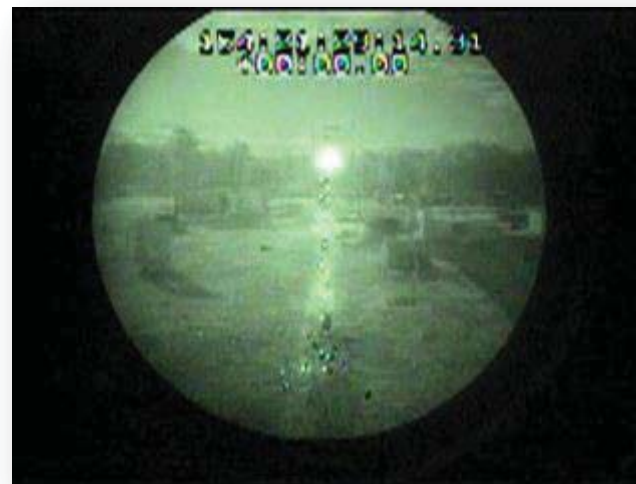
RPG In Flight

Visual Signatures of Improvised SAMs

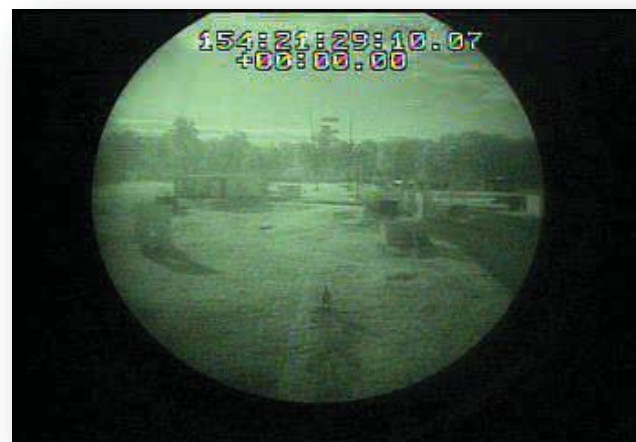
RPG Rear View NVG Video

- (S) During the interview of the (b)(3), (b)(6) crews, the two front seat pilots stated they witnessed a flash. They associated this with a suspected PG weapon, viewed from their peripheral vision. They stated that the weapon appeared to detonate on the aft pylon of EXTORTION 17, viewed through their Night Vision Goggles.
- (U) To ensure accurate weapons characterization, the pilots were provided a series of 8 videos from the VSIS (Visual Signatures of Improvised SAMs) collection, to assist in the identification of the suspected munition. The signature identification videos included MANPADS, RPGs, and Rockets.
- (S/REL) The video which best represented the munition was "RPG Rear View NVG", as identified by the crews of (b)(3), (b)(6).

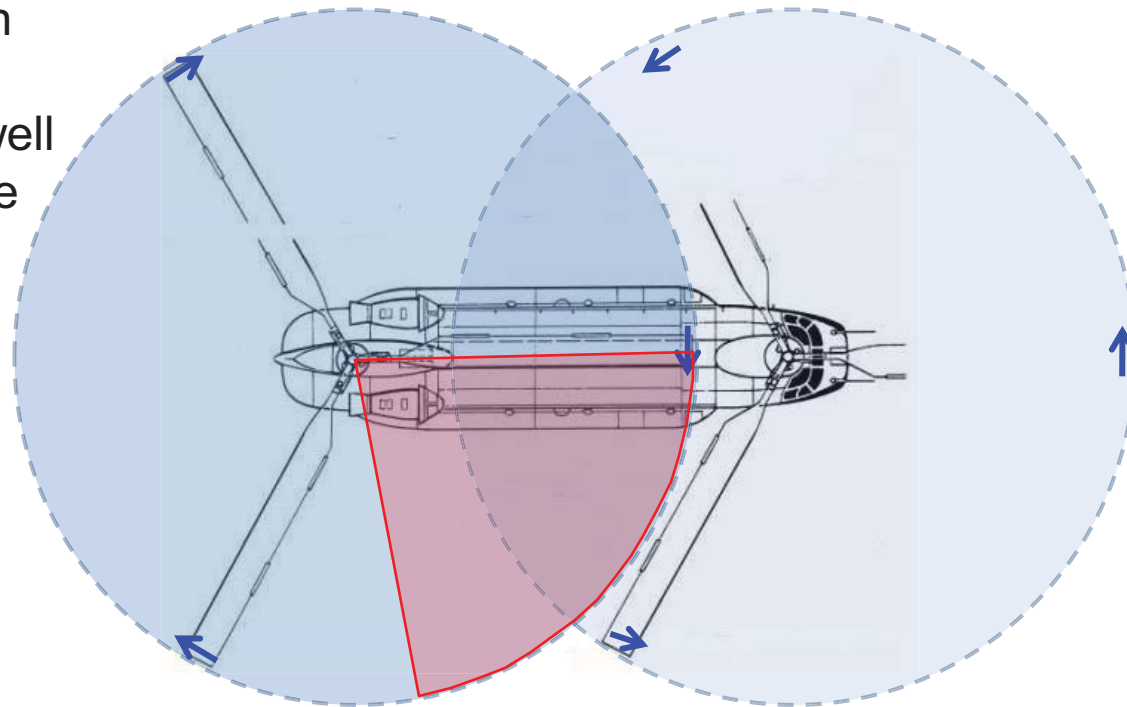
Angle of Arrival and Impact Area (U)

(U/FOUO) The angle of arrival and the area of impact within the rotor disk is an approximation based on evidence derived from EX17 as well as event specific live fire testing.

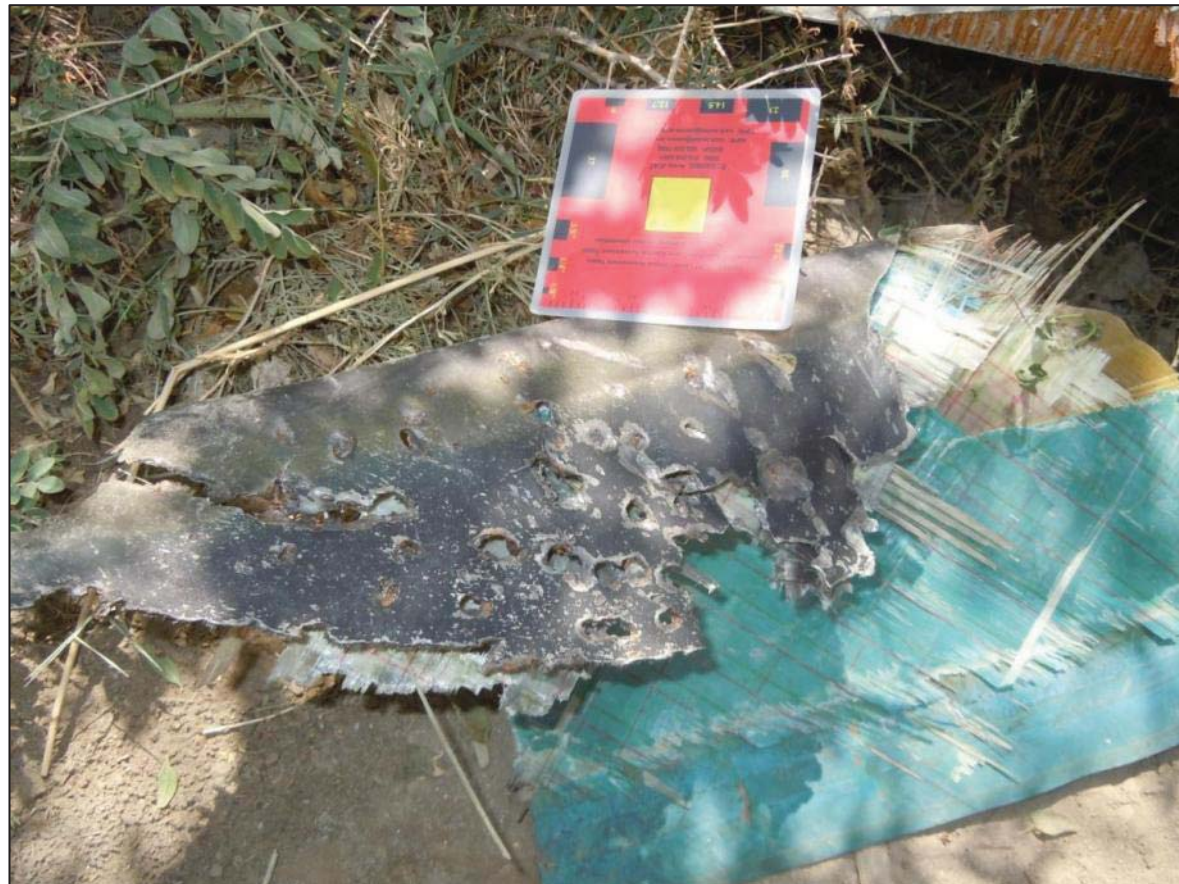
Forward Pylon (U)

(~~C~~) This portion of aft red rotor blade showing weapon effects was located near the forward pylon and associated debris.

(U) It is unknown if this portion of blade was placed there by the recovery team or by event dynamics.

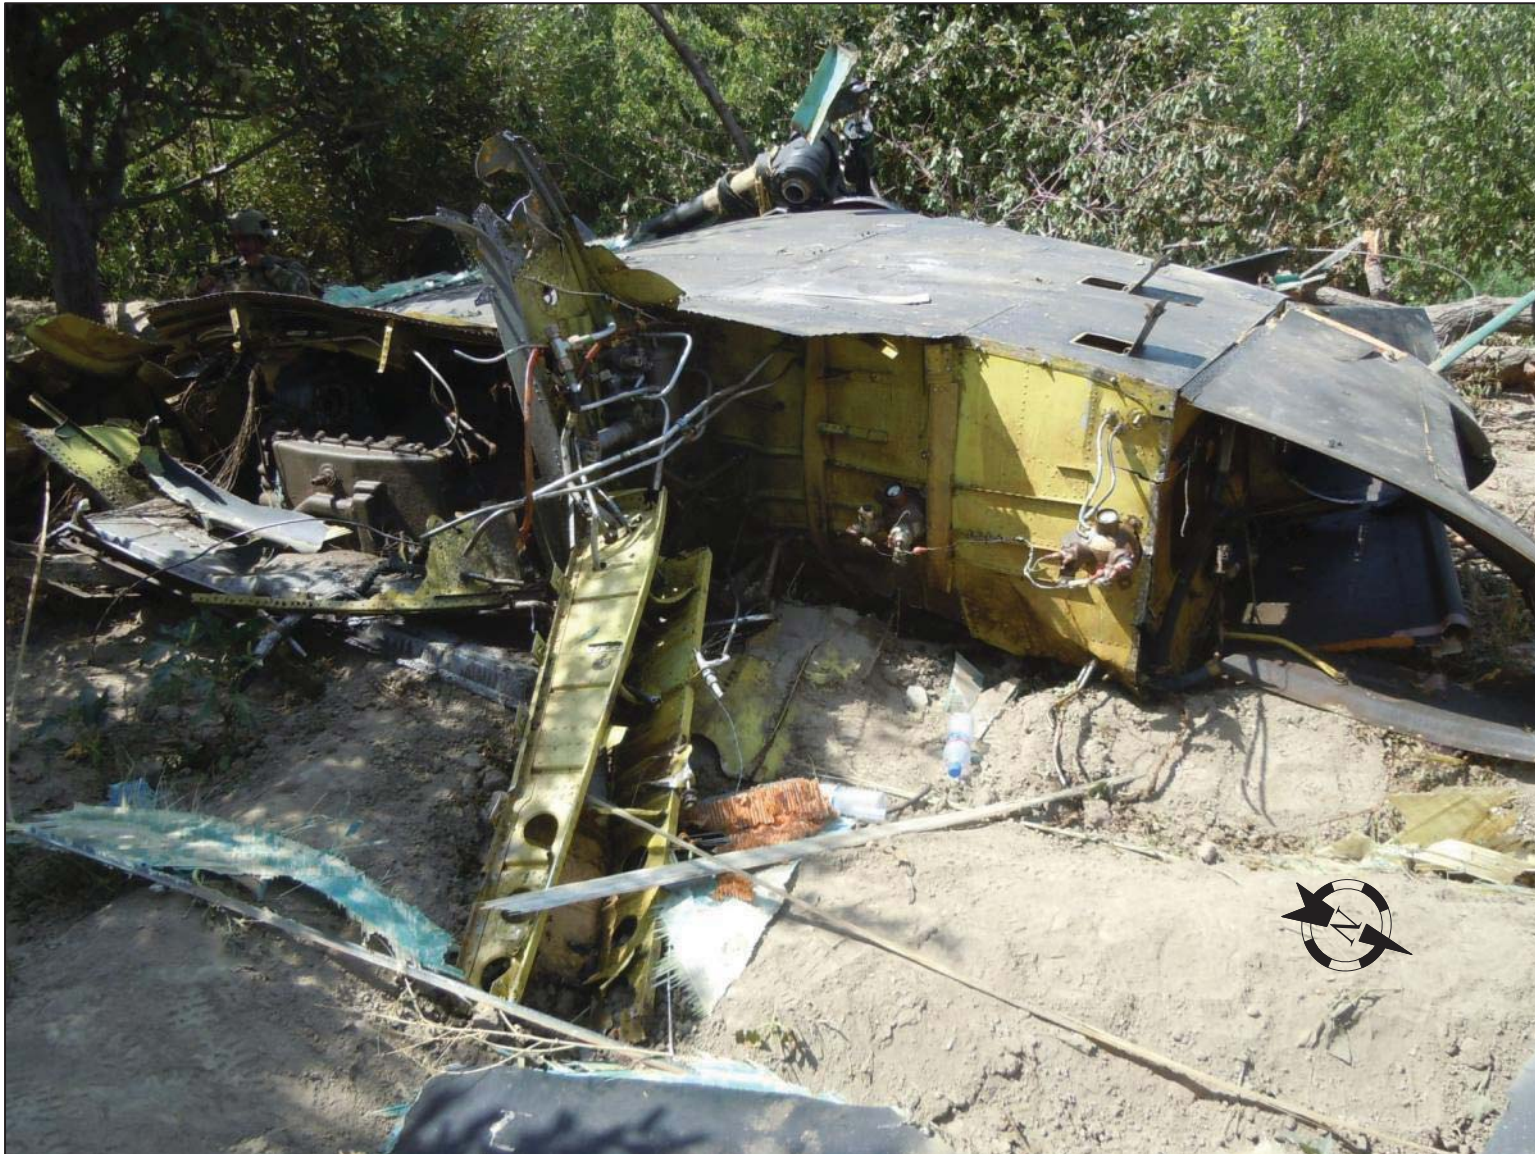
Aft Red Rotor Blade (U)

(C) Weapons effects were found on the red aft rotor blade. Prior to JCAT arrival on the scene, first responders cut the rotor blade in two locations, and piled all the aft rotor blades together next to the aft pylon (located out of frame to the right in the picture below).

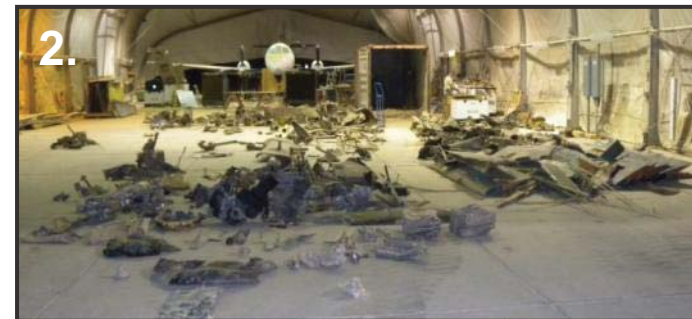
2. (U) On BAF, recovered aircraft components were unloaded, methodically inspected then sorted and placed in a two-dimensional layout by position on the aircraft.

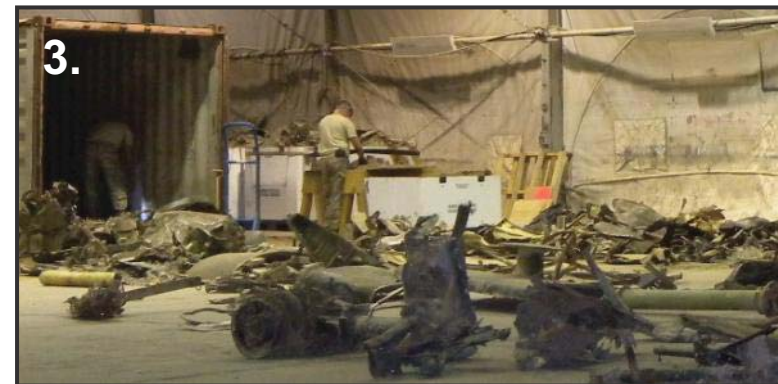
3. (U) All minor aircraft components and residual soil were sifted and thoroughly inspected for weapon effects and contextual forensic evidence.

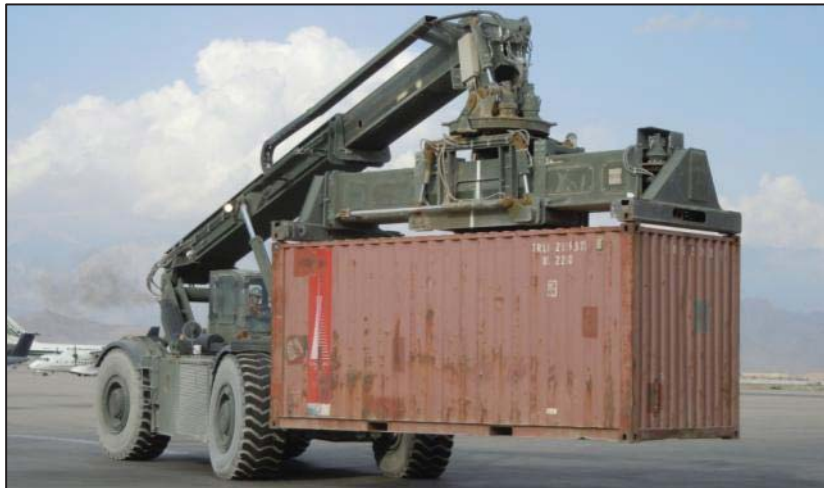
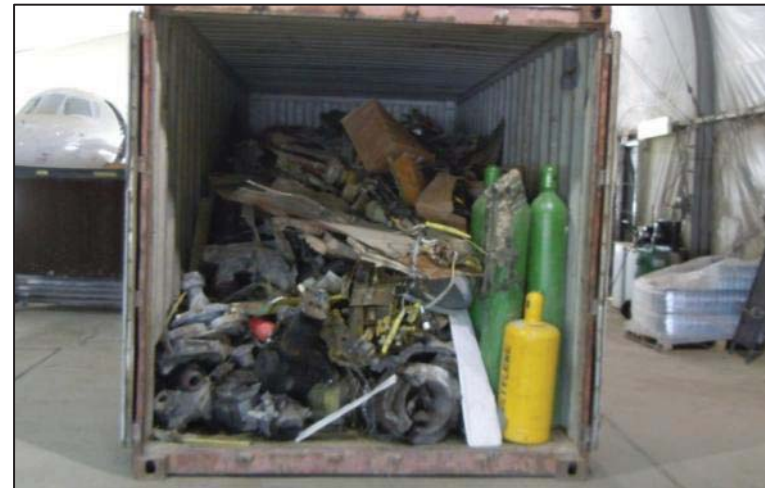
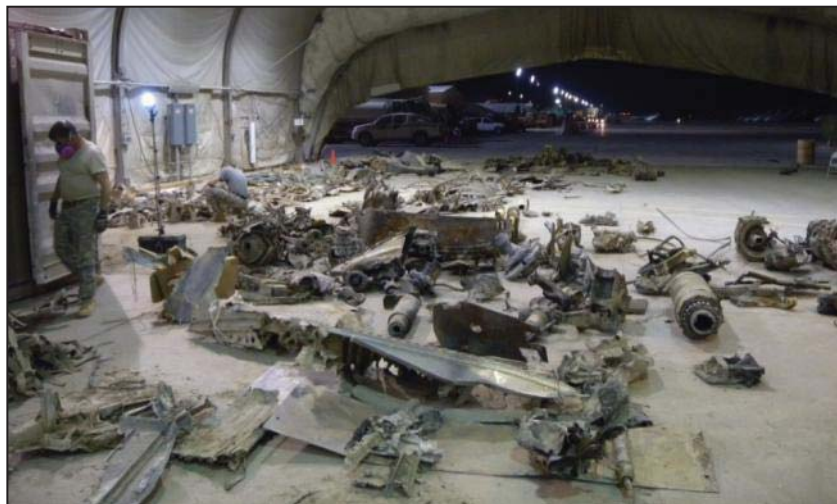
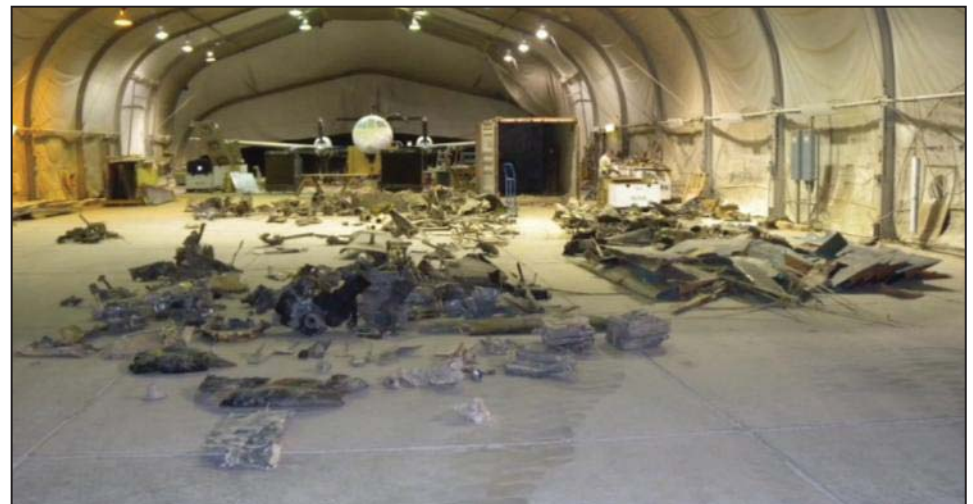
Wreckage Recovered to Bagram AB (U)

(U//~~FOUO~~) The wreckage was reduced on site, packed into a container, and shipped to Bagram AB where JCAT thoroughly examined all pieces for weapons effects.

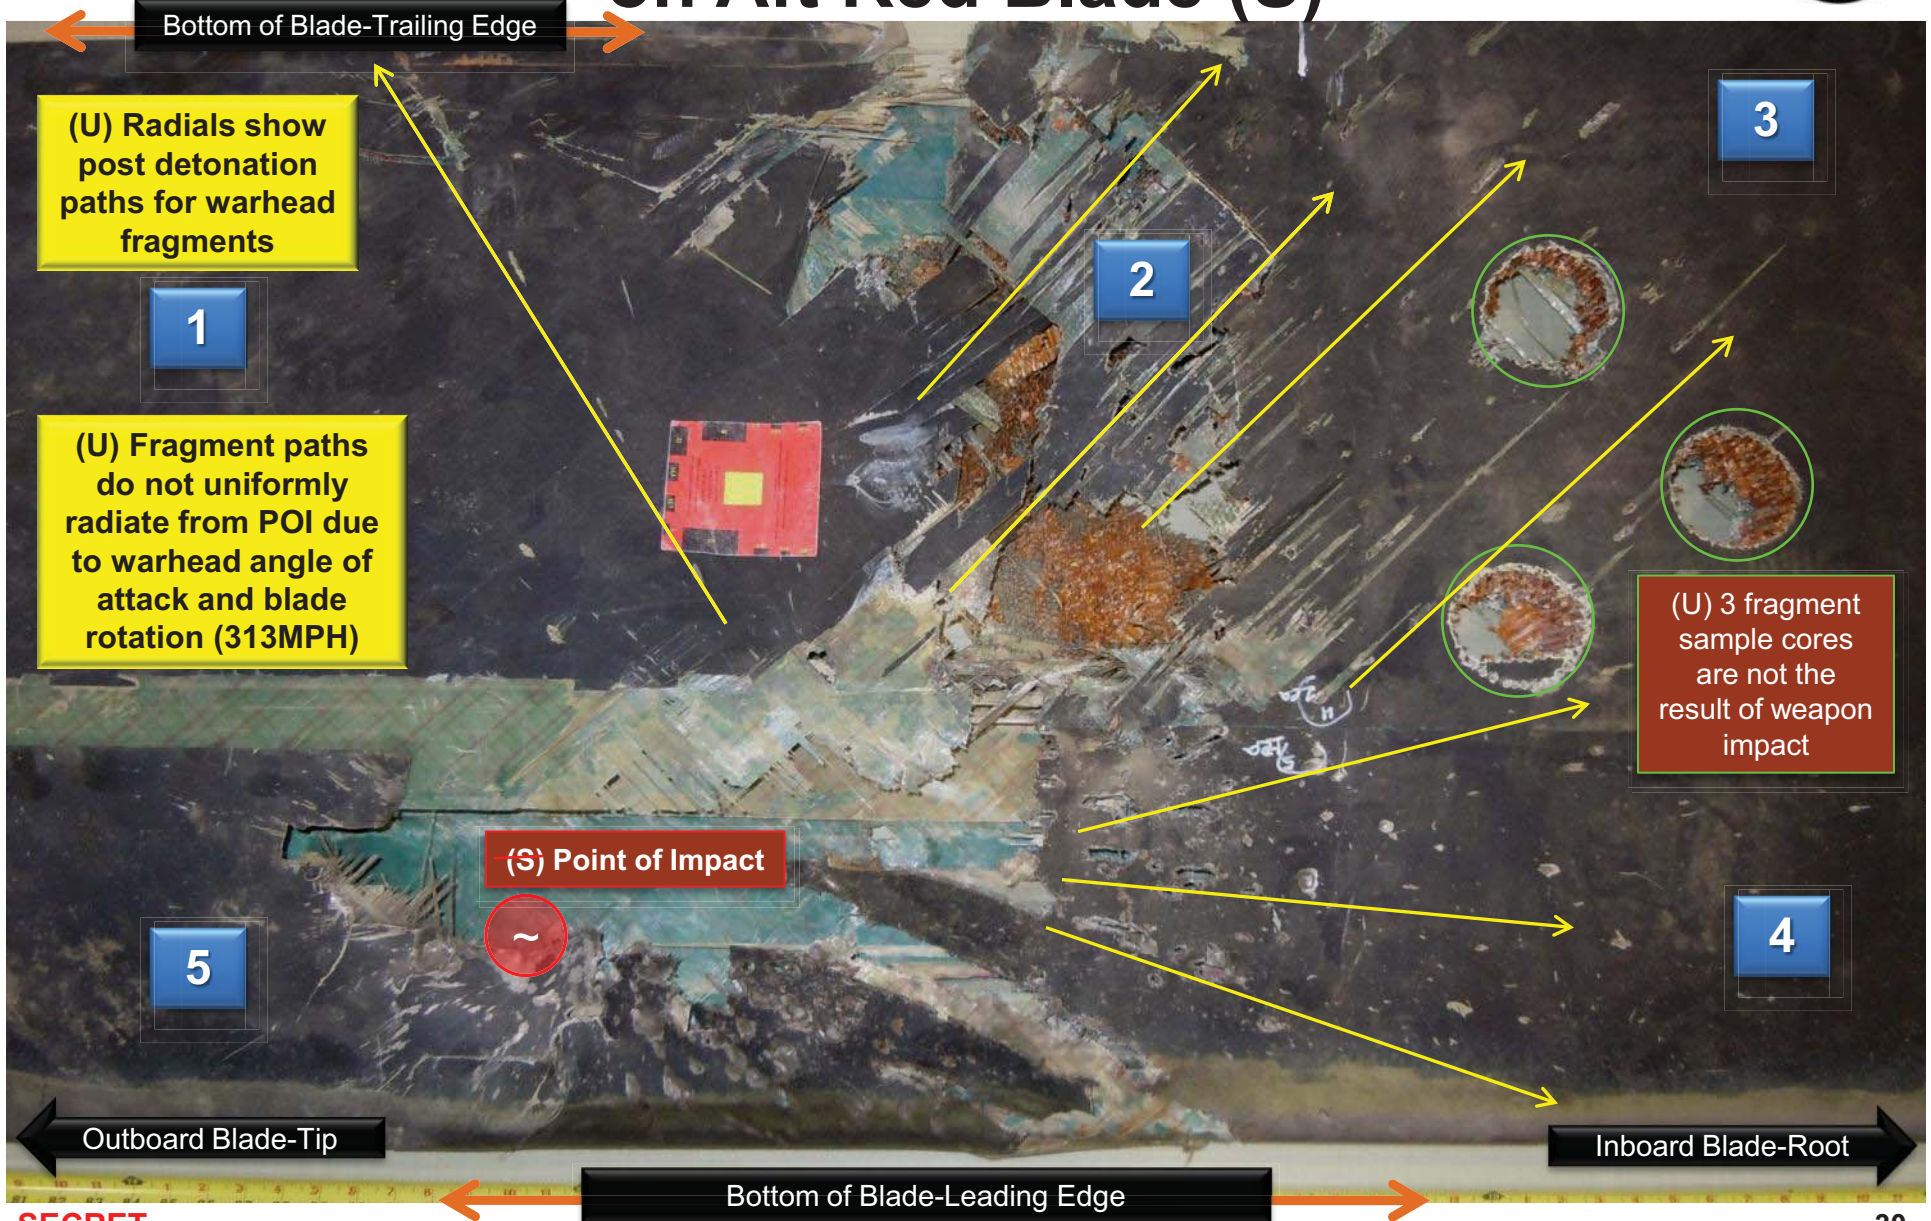
Expanded View of Weapon Impact Site on Aft Red Blade (S)

- The Threat that caused the damage to the CH-47 MRB in the combat incident was an RPG.
- The RPG was an anti-personnel variant, likely an OG-7V.
- The test results from ARL Test B4 nearly matched the data (images) provided by the ASDAT.
- Minor variances in the results (test versus combat incident), mostly the loss of material in the trailing edge, were due to the blade spar separation and material contact with the ground.
- While the spar did not sever in test B4, if loaded, it is highly likely that the spar would have failed as witnessed in the combat event.

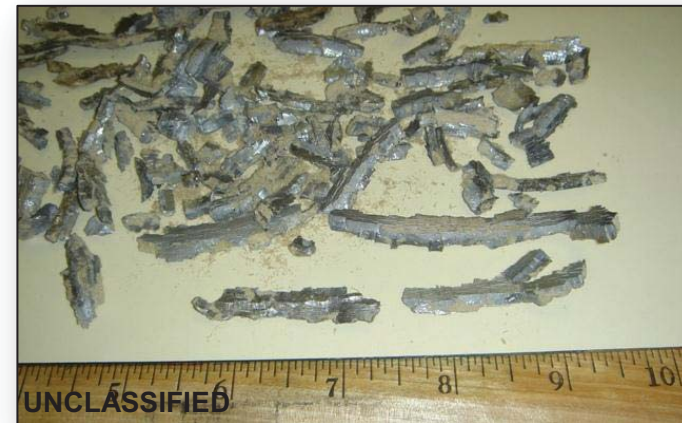
Bulgarian OG-7V Fragmentation Sample Lot

(U) WARHEAD: Fragmentation body, which is little more than a hollow steel pipe filled with explosive. On impact more than 65% of the warhead body is converted into fragments having masses of more than .5 grams. The warhead is filled with 210 - 350 grams of explosive (model dependant) which is 95% RDX and 5% binder.

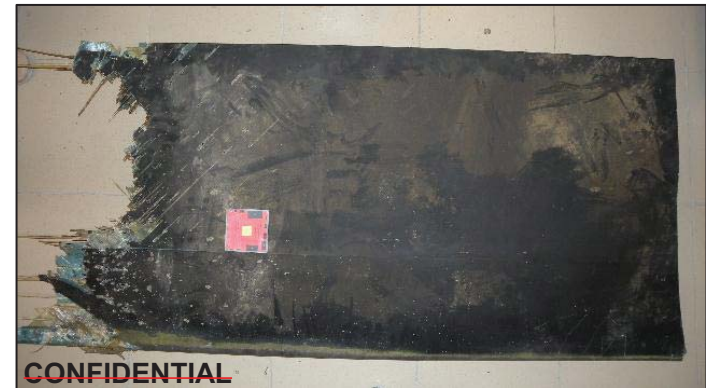
(C) The aft red rotor blade was X-rayed by the Craig Hospital (Bagram) radiology department.

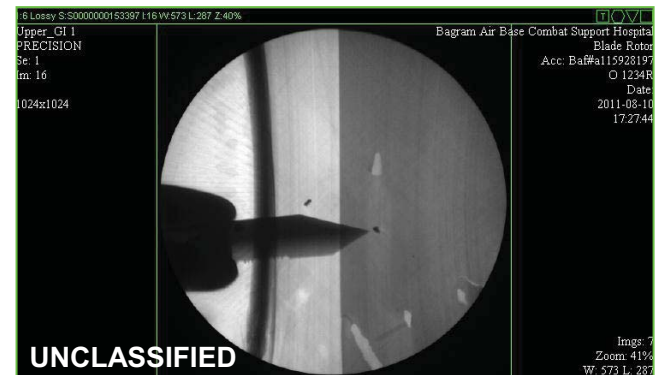
(U) Retained fragment locations were identified and marked on the blade surface.

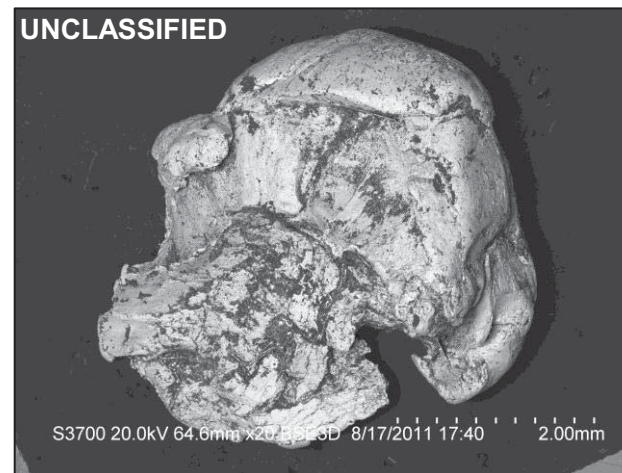
~~(S)~~ Incident Fragment

2x3x4mm
Iron 95.78%
Aluminum 2%
Silicon 1.47%
Manganese 0.76%.

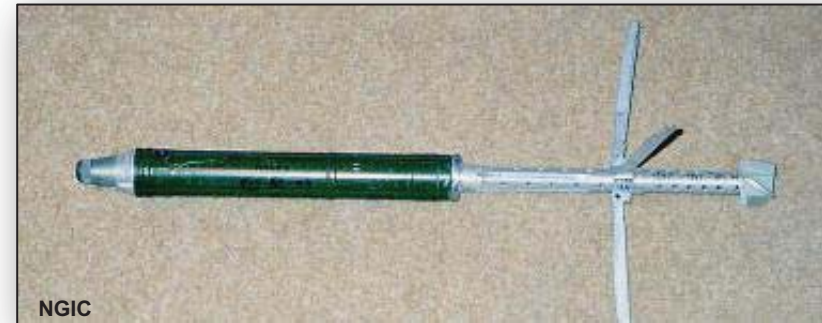
OG-7 Antipersonnel Round

(U) PG rocket motors use a double base propellant of nitroglycerin and nitrocellulose.

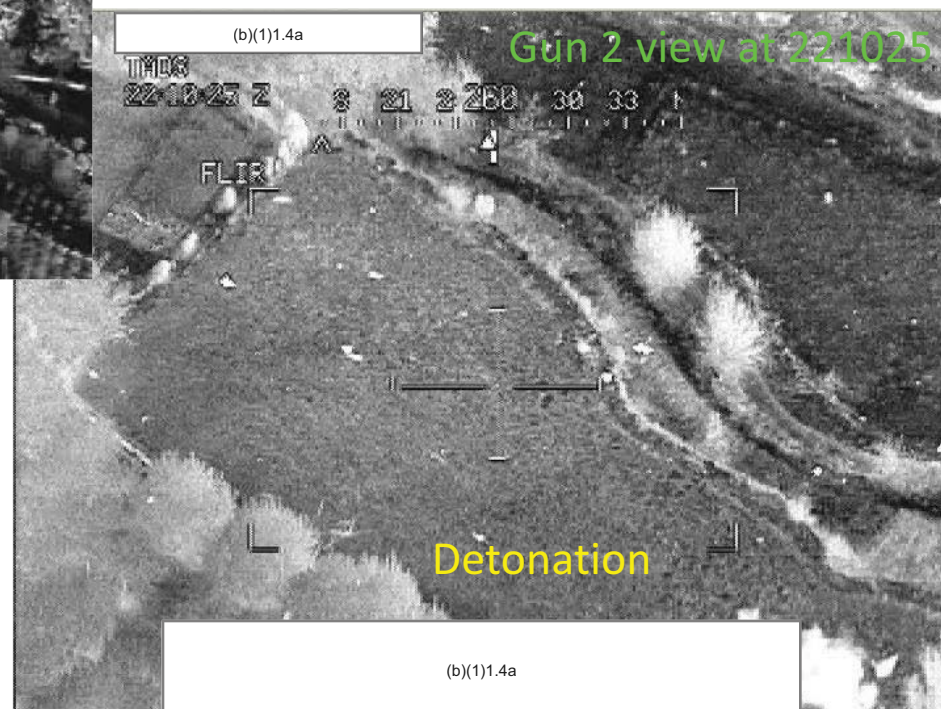
Speculated RPG Impact – AH Gun Tape (U)

- Flash visible to both AH crews @ 220948
- AC130 crews report 3 shots in ~9 seconds
- Gun 1 begins shooting @ 221019
- Detonation first visible at 221025
- Detonation associated with 1st round of 3rd 30mm burst

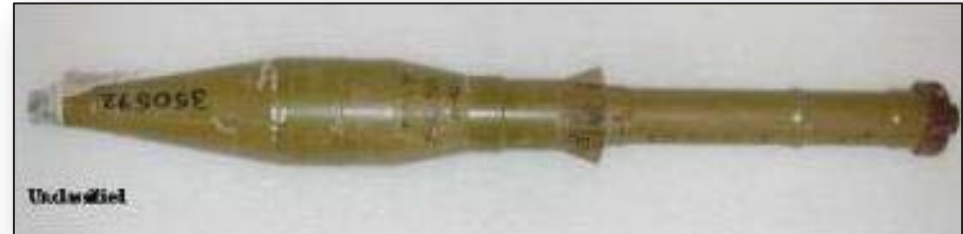
PG-7S

Explosive Composition: 95% RDX (PG-7L uses
HMX only).

Propellant: Double base propellant of
nitroglycerin and nitrocellulose.

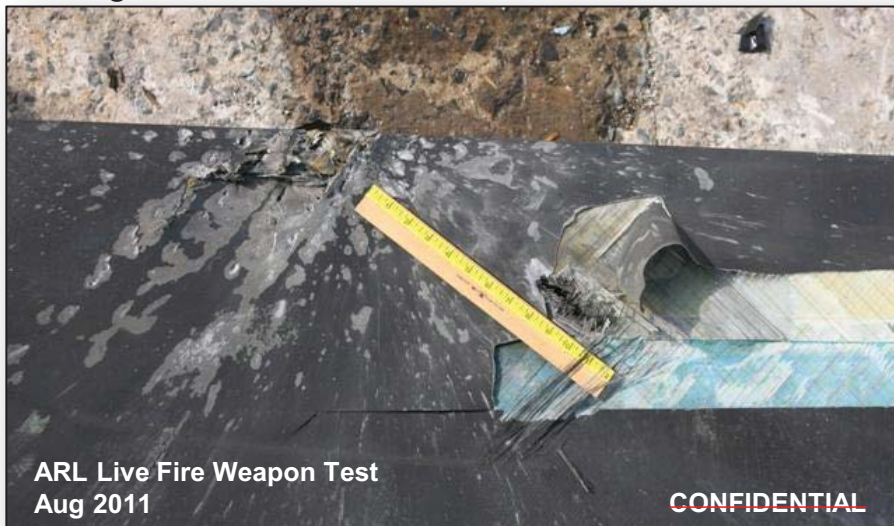
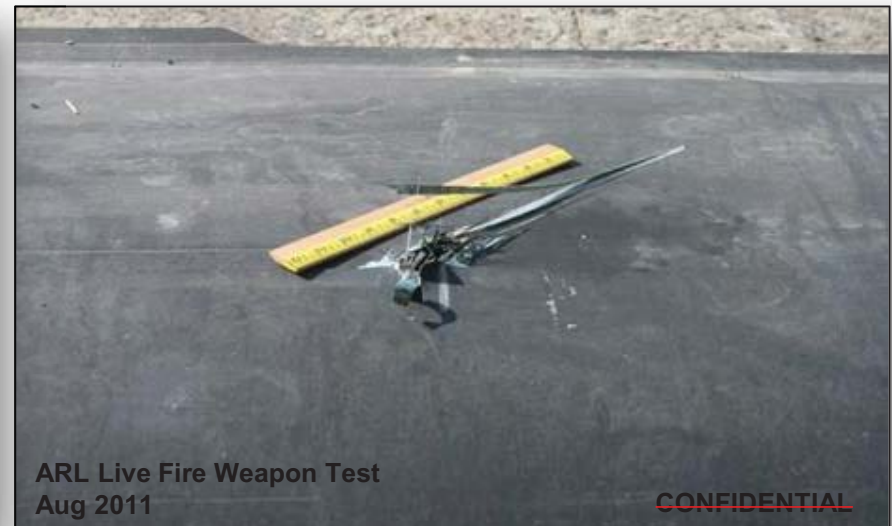
(C) These pictures illustrate damage caused to a CH-47 rotor blade via a static test with an Iranian Nader (PG-7 variant). The Nader is a High-Explosive Anti-Tank (HEAT) round and possesses similar capabilities to the standard PG-7 variant seen throughout the OEF theater.

(U) The picture at left shows the bottom of the blade. The round was oriented in the direction of the ruler (from left to right, top to bottom). A hole caused by the copper penetrator is clearly visible toward the right side of the ruler. The picture at right shows the top surface of the blade, where the penetrator exited the structure.

(U) Note the lack of fragmentation damage on both the bottom and top surfaces of the blade. Other distinguishing characteristics include the hole from the copper penetrator and minor, natural fragmentation damage to the bottom surface of the blade.

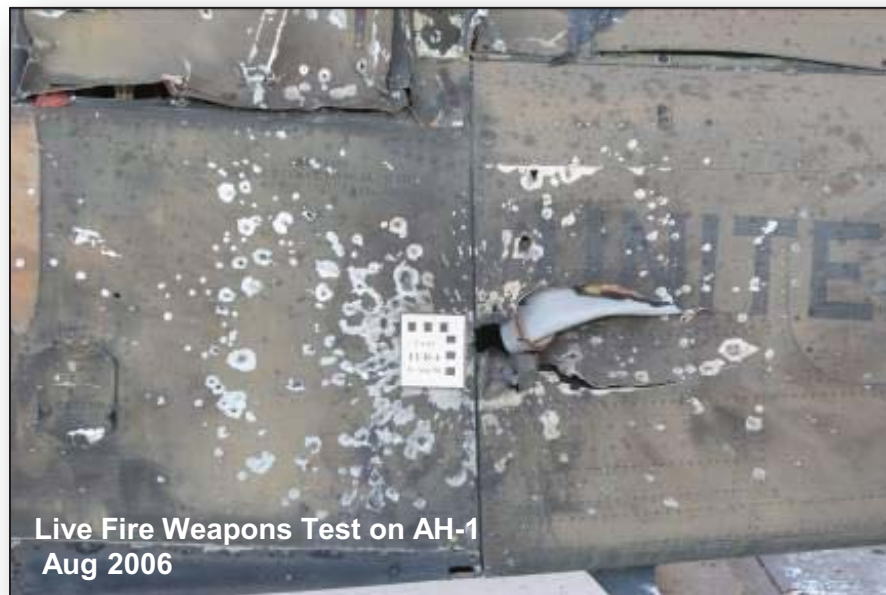
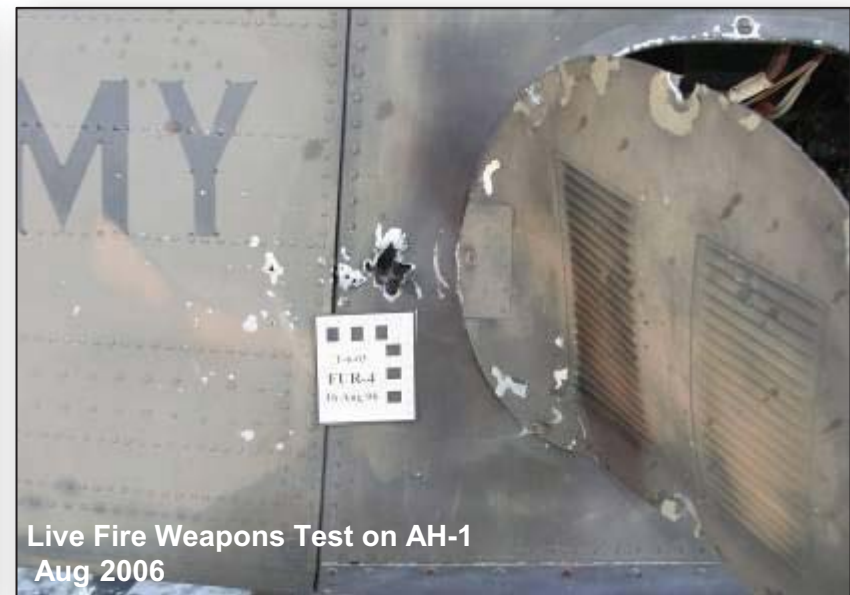
(S) These pictures illustrate damage caused to an AH-1 fuselage by an S-5K rocket static test.

(S) The picture at left details the entry damage. Note the natural fragmentation damage, as well as the increased size of fragments as compared to a PG-7 variant.

(S) The picture at right shows the exit damage, where the penetrator passed through the opposite side of the fuselage.

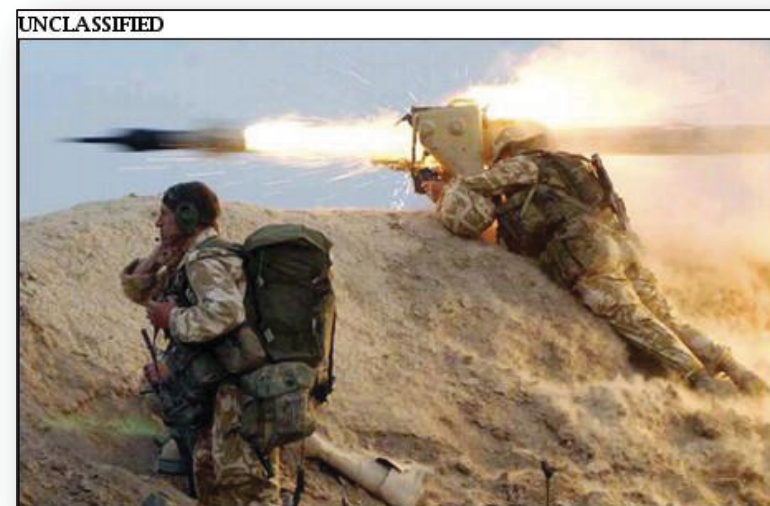
Milan ATGM

~~(S)~~ Milan Explosive Composition: 80% RDX, 20% TNT

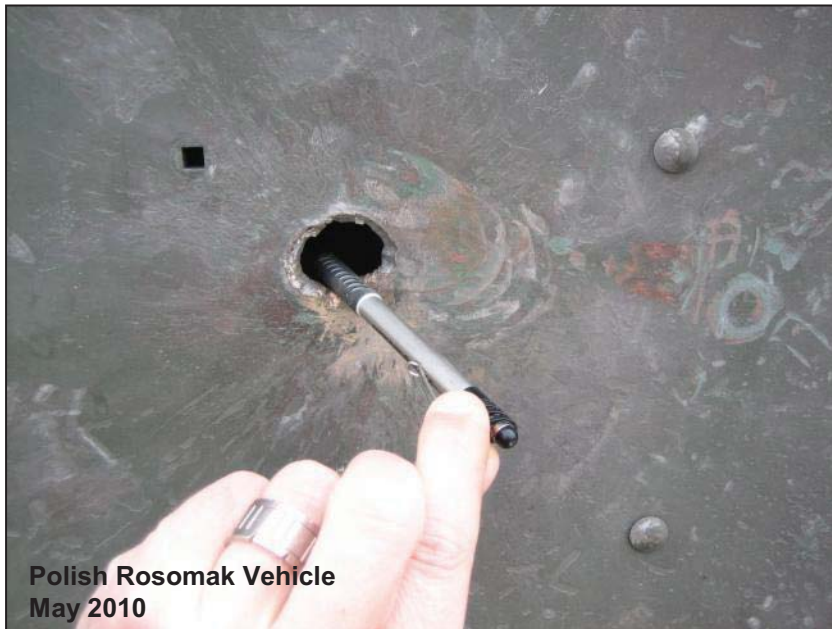
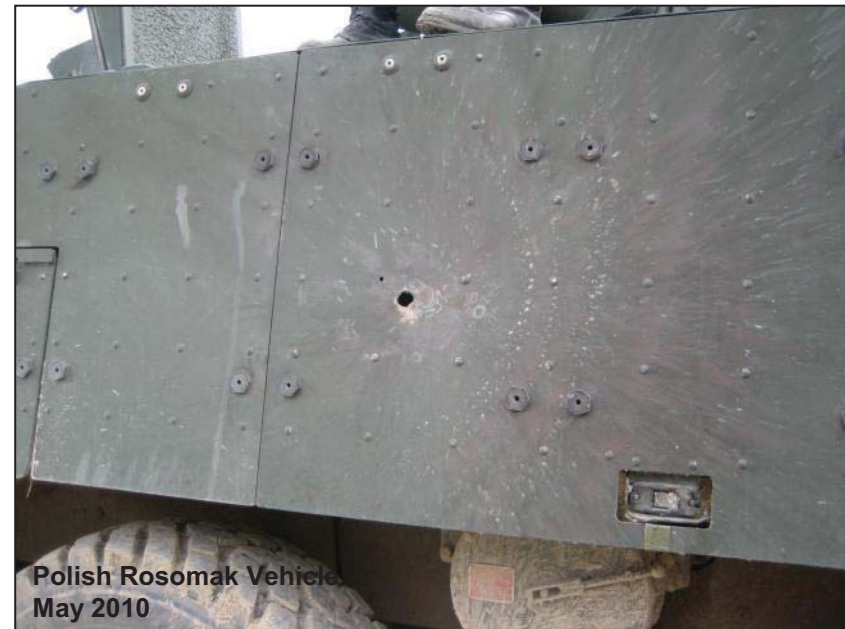
- (S) These pictures illustrate damage caused to a Polish Rosomak vehicle by a Milan ATGM.
- (S) The picture at left details the damage caused by the penetrating function of the warhead.
- (S) The picture at right shows the general damage.
- (S) Note the lack of fragmentation damage to the vehicle. The primary destructive mechanism is the explosively-formed penetrator as well as blast overpressure.

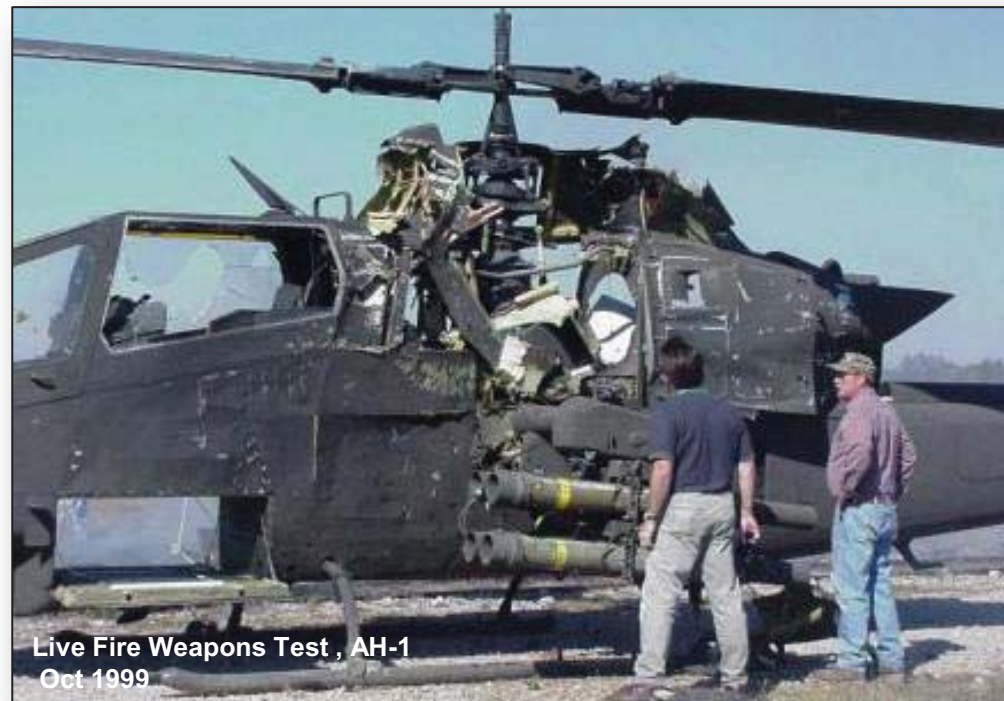
(S) This picture illustrates the damage caused to an AH-1 helicopter by a Fagot (AT-4) test fire.

(S) Most of the damage to the aircraft was actually due to blast overpressure as opposed to the shaped-charge jet. The shaped-charge jet punched a fairly small, localized hole through the aircraft doing little collateral damage. Furthermore, little fragmentation damage was observed to the aircraft. The majority of the damage appeared to be caused by the associated blast wave.

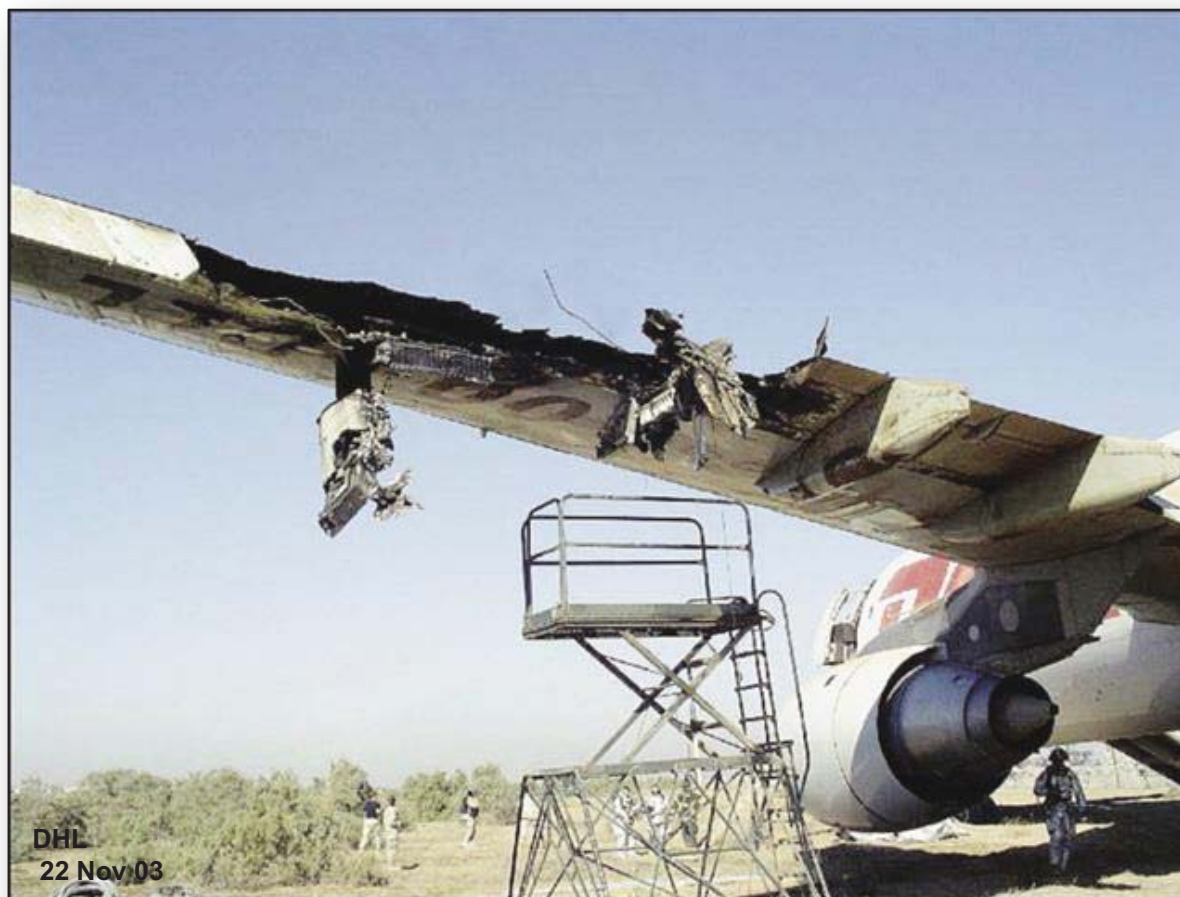
~~(S)~~ This DHL aircraft was hit by a confirmed SA-7 MAPADS. Note the extensive damage to the wing structure.

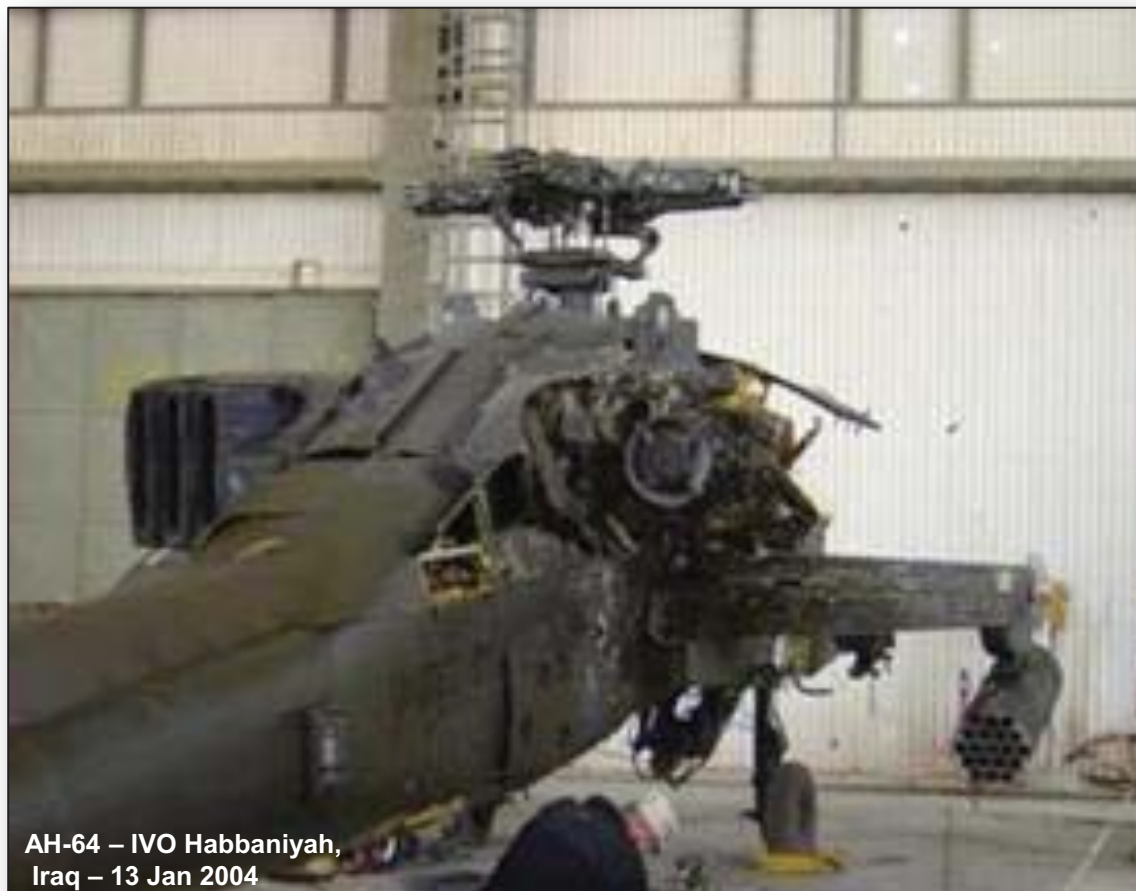
AH-64 – IVO Habbaniyah,
Iraq – 13 Jan 2004

(S) This AH-64 was hit by a confirmed SA-16. Note the extensive fragmentation damage to the number two engine nacelle, right side wing and fuselage.
